Project 1080 – Restore Stock Car #5995

Project 1089 – Repairs to Sheep Car #5633

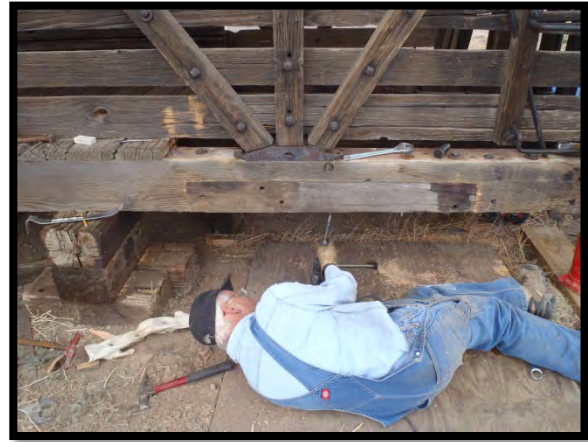
The splice in the side sill is perfect! You just can't get a better fit.

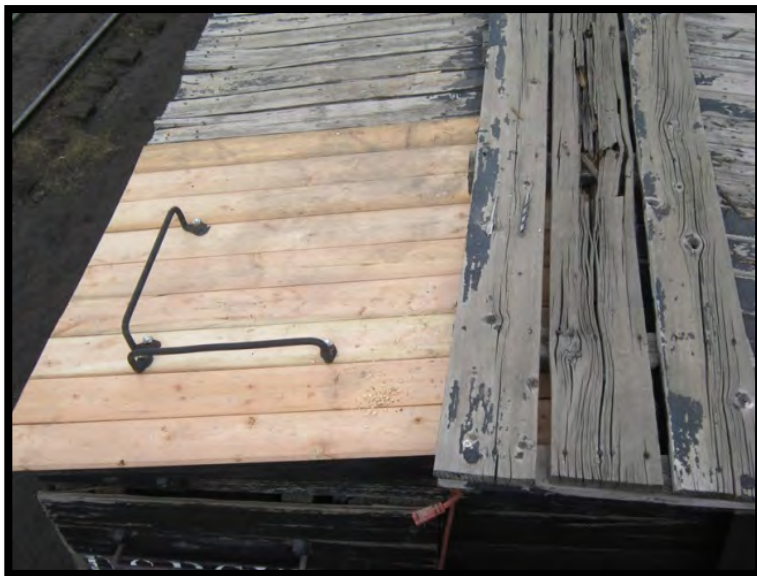
Some roofing boards were removed and replaced to secure the roof grab iron.

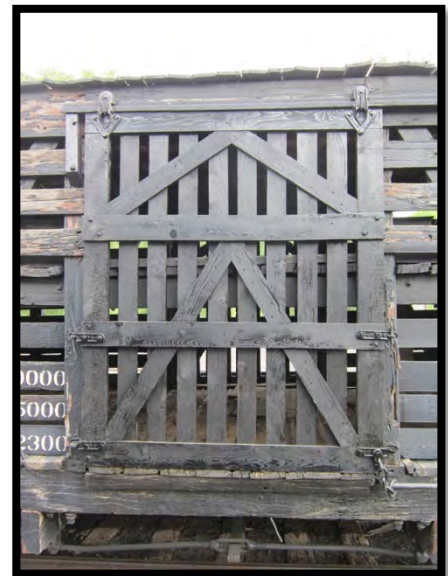
New door built, hung, primed and painted.

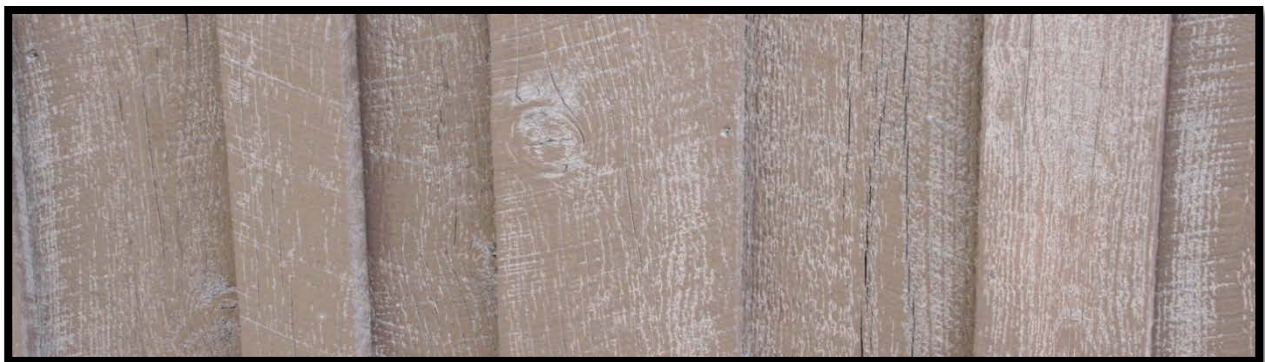
Note that the oil based finish coat did not adhere well in the cracks to the primer. See the photo below. This is the second coat of paint. I suggest another coat of Latex paint to fill the cracks in the paint. This can be done in the F Work Session.

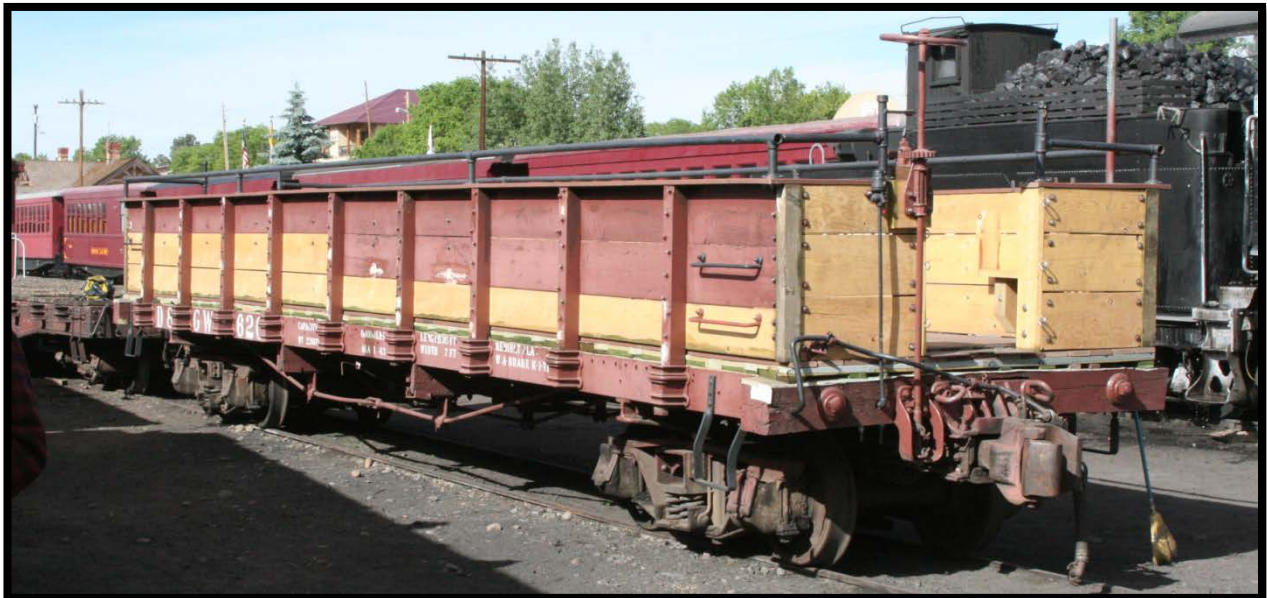
The gondola was sprayed with watery soot on Tuesday morning by the scheduled train as it left Chama. The soot was not able to be removed from the primed car. Two coats of Babbit Brown

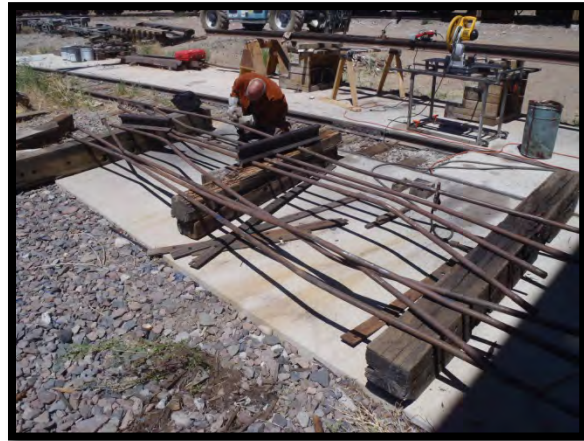
Worn truss rods were built up by welding them and then the welds were ground down as close to the original truss rod size as possible.

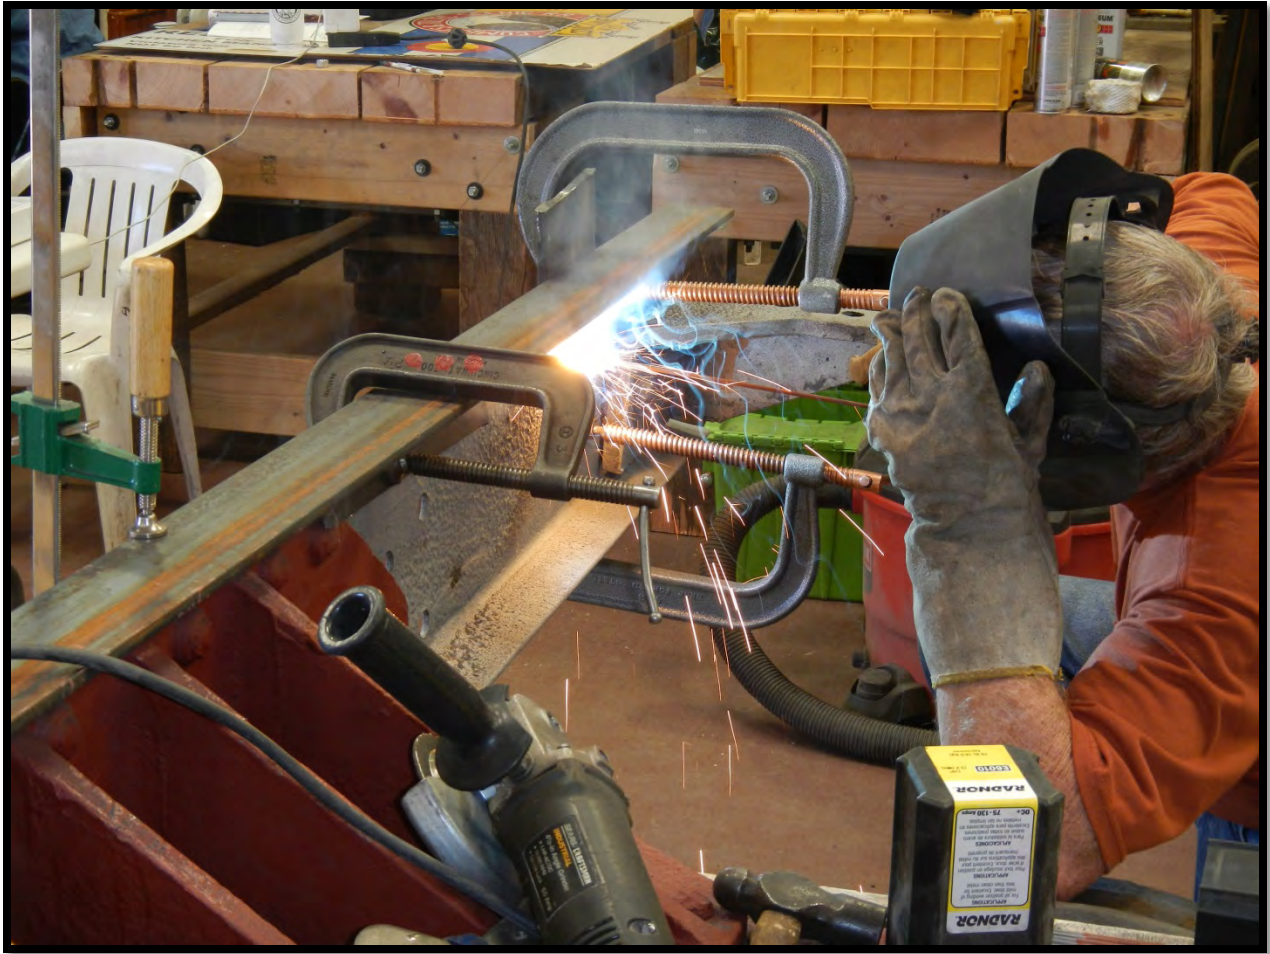
Session G: Fuzzy cut a replacement for the top of the A end sill which was badly corroded and Russ Hanscom welded it in. (Picture on the next page.)

Russ Hanscom welding new steel on DGB #783 end sill.

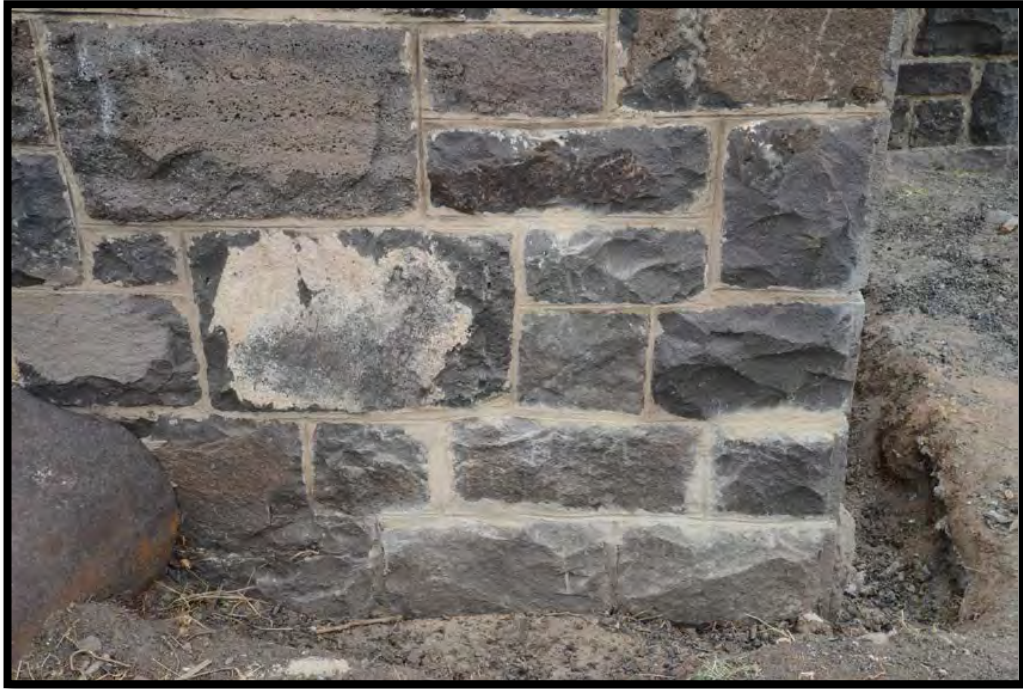
Figure 1: Trench work and repointing at lower NW corner of North wall.

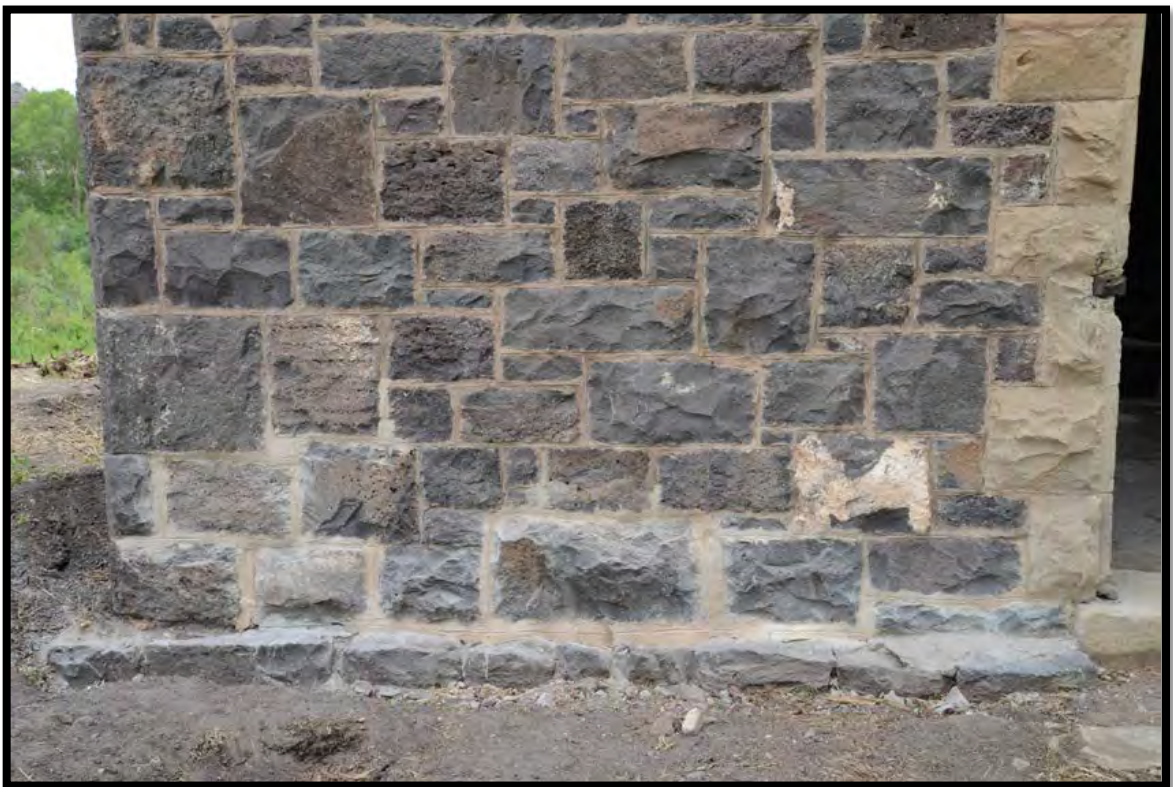
Figure 2: Repointing of lower SE corner of East wall. Foundation stones were exposed by trenching.

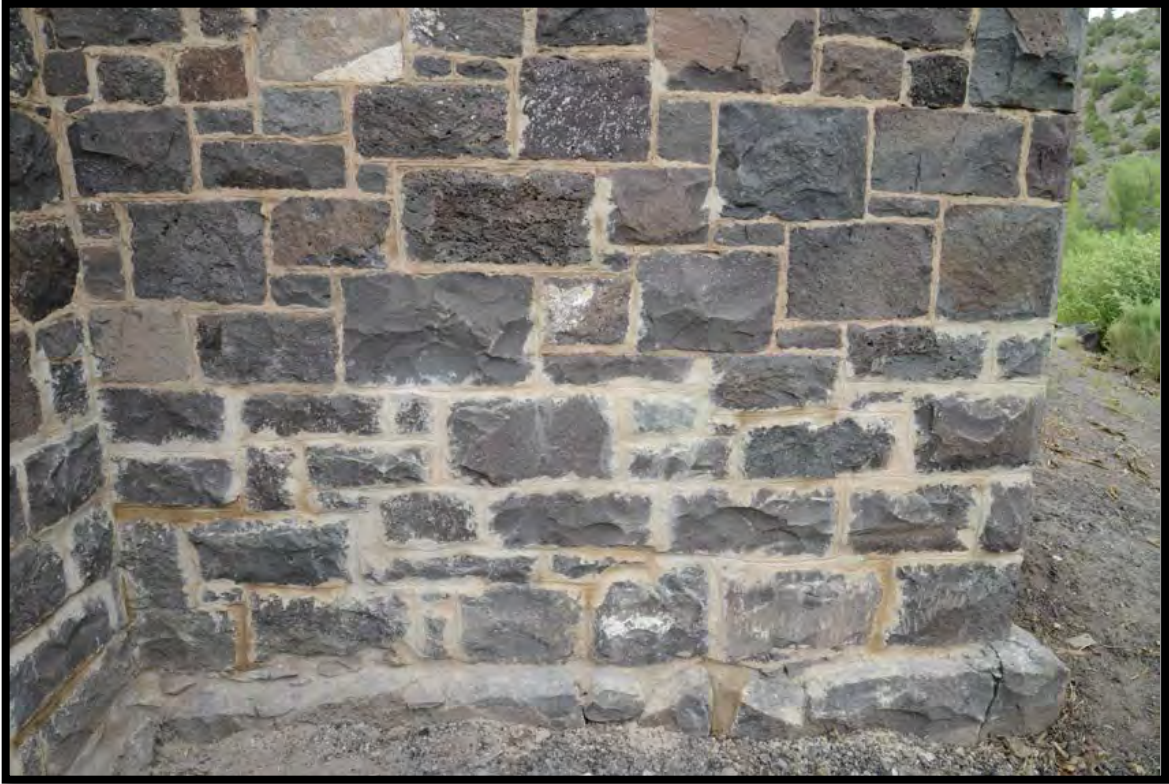
Figure 3: Foundation stones and repointing of lower SW corner of West wall. Dark colored mortar was still wet when photo was taken.

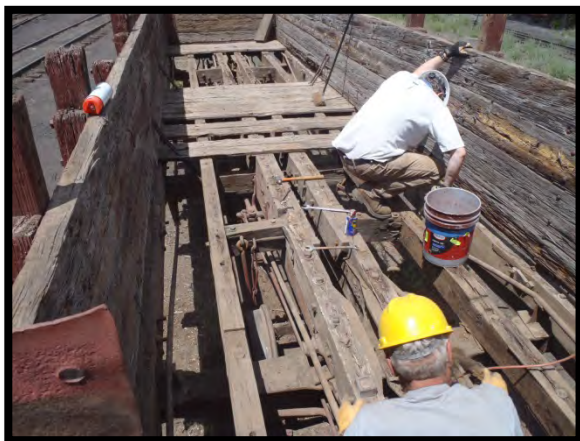
Rotten wood being removed from the floor.

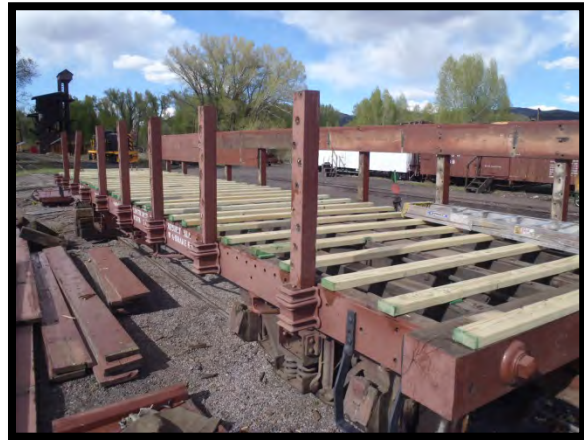
With most of the old rotten wood removed new 2 X 4's have been screwed into place.
