Job 1017 Coal Tipple Restoration - 343.994

Objective: Restore the Chama Coal Tipple using the winter, 2002, Structure Report/Maintenance Plan by Kells/Kreis.

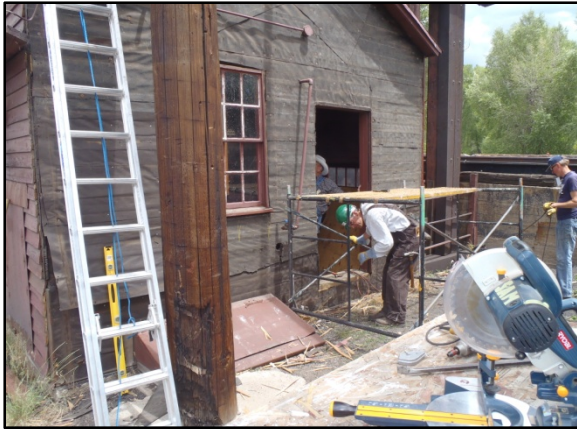
Old siding has been removed from the south side of the hoist house.

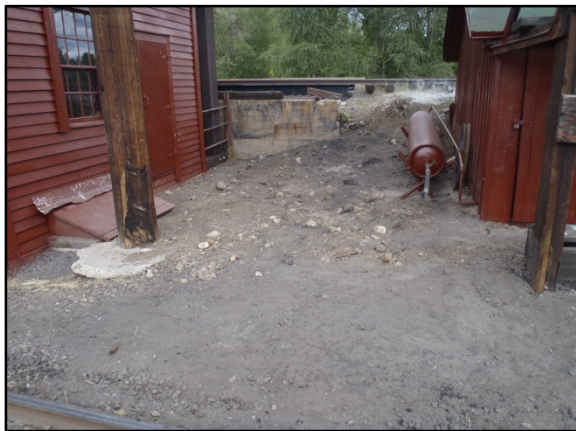
Lightning protection ground loop and ground enhancing material has been installed and hole backfilled.

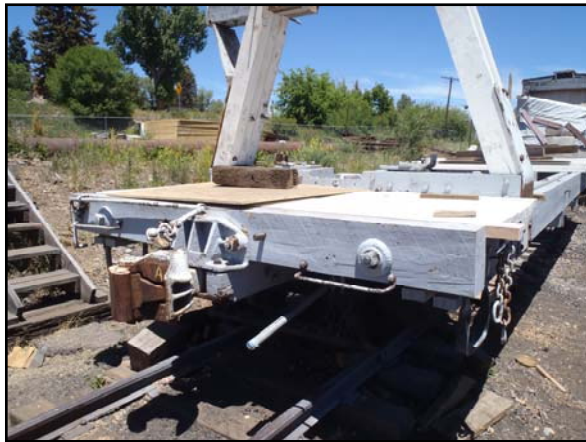
The A and B end couplers were installed. Both the A and B end coupler pockets had been installed at the wrong height and had to be lowered about 1 1/2" each. The A end coupler cheek plates had been installed with 4" spacing, which would not accept a 5" coupler shank. Ultimately, the A coupler draft timbers were removed and relocated laterally outwards to provide sufficient spacing for the coupler shank. These rework activities consumed a considerable amount of effort. Part of the confusion may have resulted from there being different types of couplers and related parts at opposite ends of the car. A number of grab irons and foot loops were installed. A different procedure for installing the couplers was tried and found to be superior to using the tractor. It requires a stack of blocking on the car and a beam to serve as a cantilever gantry. A come-a-long is attached to the coupler release eye, which keeps the coupler right side up during lifting and installation. The coupler knuckle is removed and a bar is inserted to balance the coupler in the long direction. Later, a hydraulic jack is placed under the coupler loop for final alignment.

“A” end coupler installed.

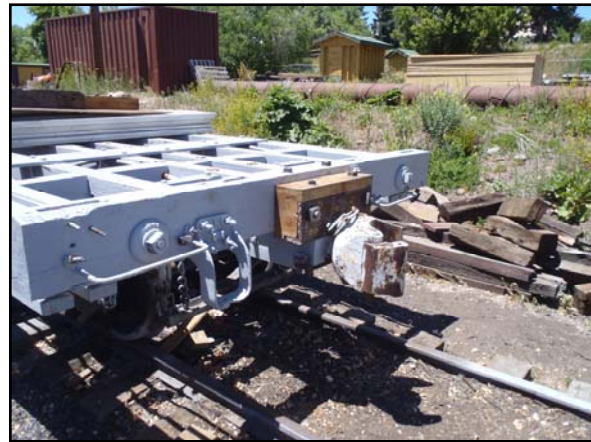
”B” end coupler installed.

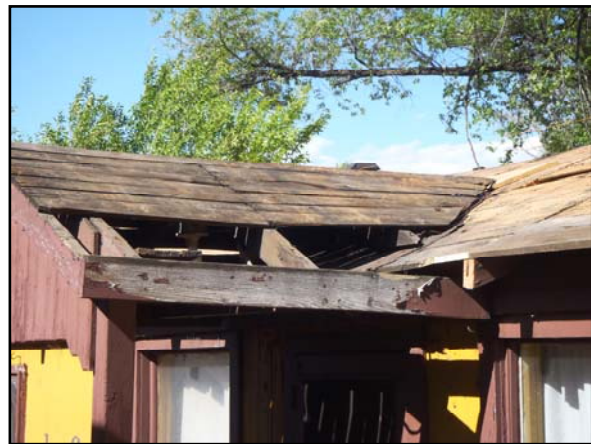
Exposed roof showing rotted wood that needed to be removed and replaced.

Problems Encountered: Once the existing roofing material had been removed, an inspection of the decking and roof structure revealed that the roof structure appeared to be substandard. In particular, the rafters were on 36”-42” centers, rather than the normal 24” centers. It is also speculated that the roof trusses are probably under-designed. The complete replacement of the roof structure was beyond the intended scope of this project. It is strongly recommended that, although the existing roof has endured several years, the entire roof (surface and structure) be replaced in the near future.

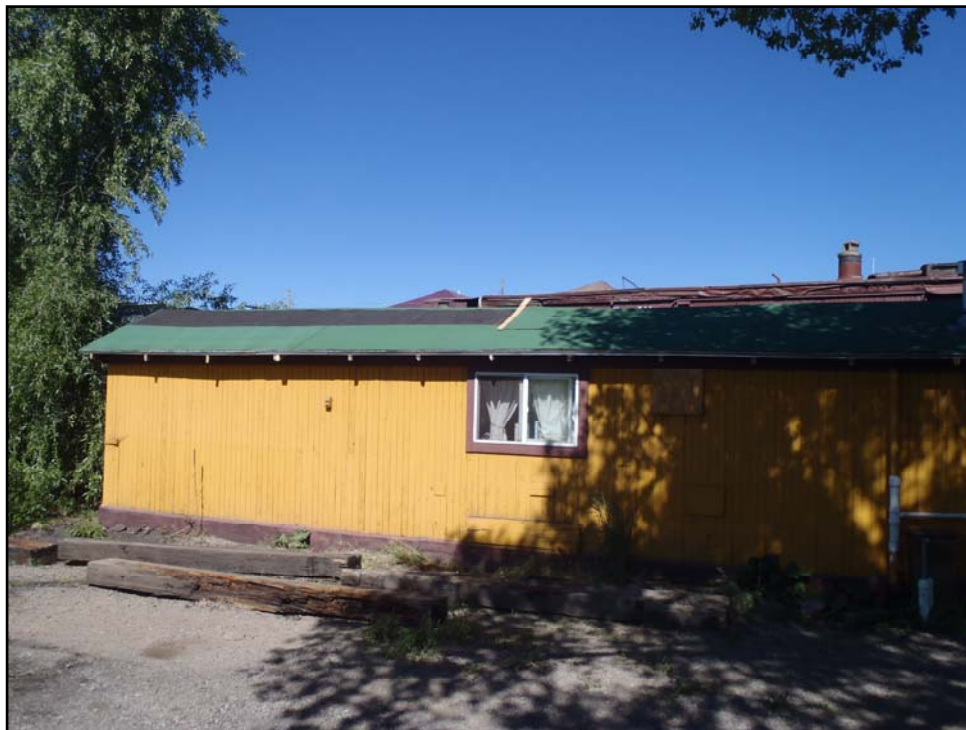
Another problem was a shortage of material. While the team leader ordered 6 rolls of mineral roofing, only 5 were delivered. Every attempt was made to make full use the material on hand, including some material left over from years gone by. This “hand-me-down” material had been improperly stored and had become almost entirely unusable. Out of the several rolls available, only about one-third of a roll was passable. The rest were discarded to eliminate the temptation of trying to foist them on to future projects.

Reroofing was completed during Session C except for the black area at the top left of the roof. Additional material arrived on Monday of Session D; however, the final piece was not laid until Session E. (see next page)

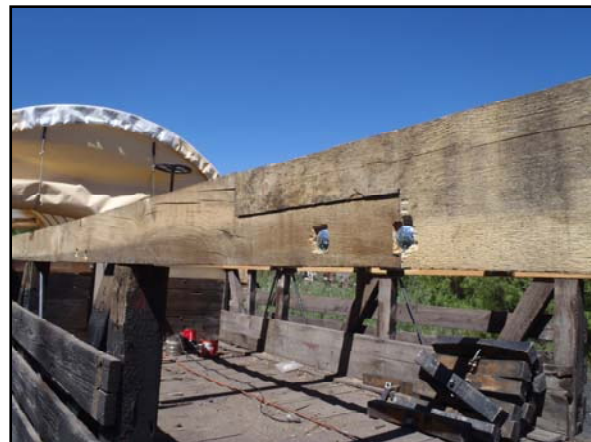
A spliced upper side sill has been installed.

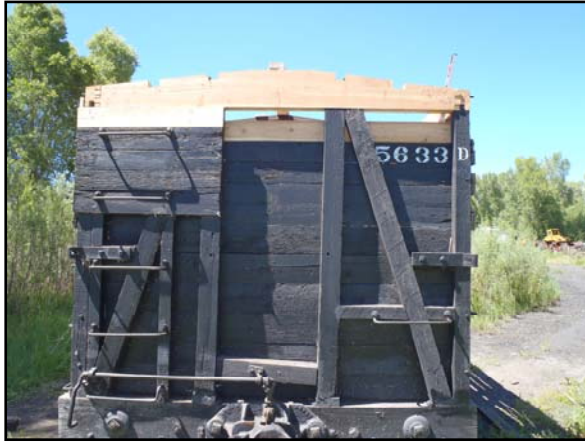
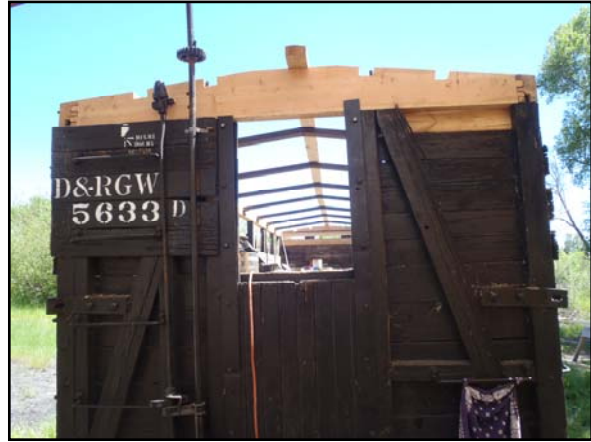
Upper end sills, upper side sills and metal rafters have been installed. New longitudinal purlins were drilled and installed.

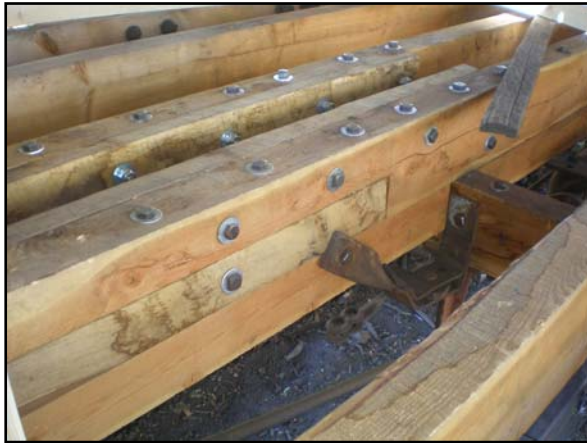
Sills spliced and bolted together.
