Project 1080 – Restore Stock Car #5995

Project 1089 – Repairs to Sheep Car #5633

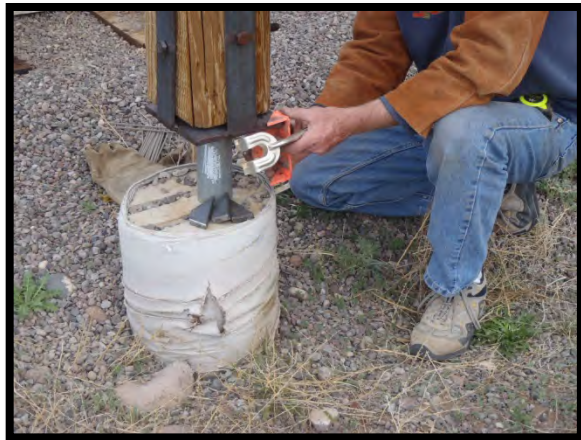
As a result of one or more questionable welds between the pole base plate and supporting pipe post, it was decided to install gussets on all such joints. At three gussets per base plate, 96 gussets were cut and welded in place, not an easy task as all of the welding was uphill or overhead positions. This required two days.

TL Russ Hanscom clamping piece in place to make sure gussets are in correct place and lined up for welding.

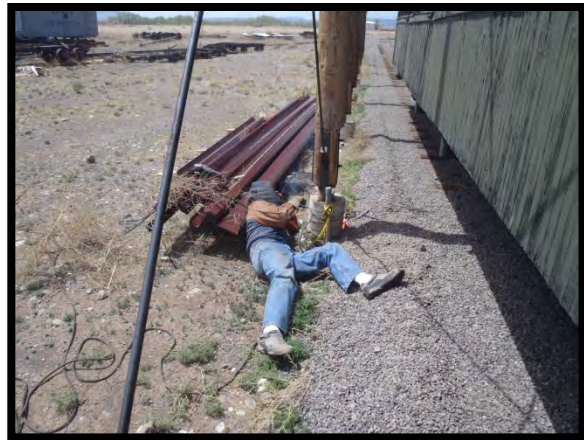
TL Russ Hanscom welding gussets in less than ideal conditions.

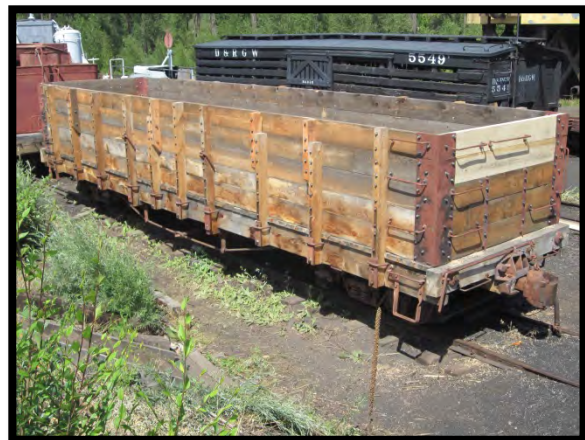
Finished car, ready to be primed, painted and lettered.

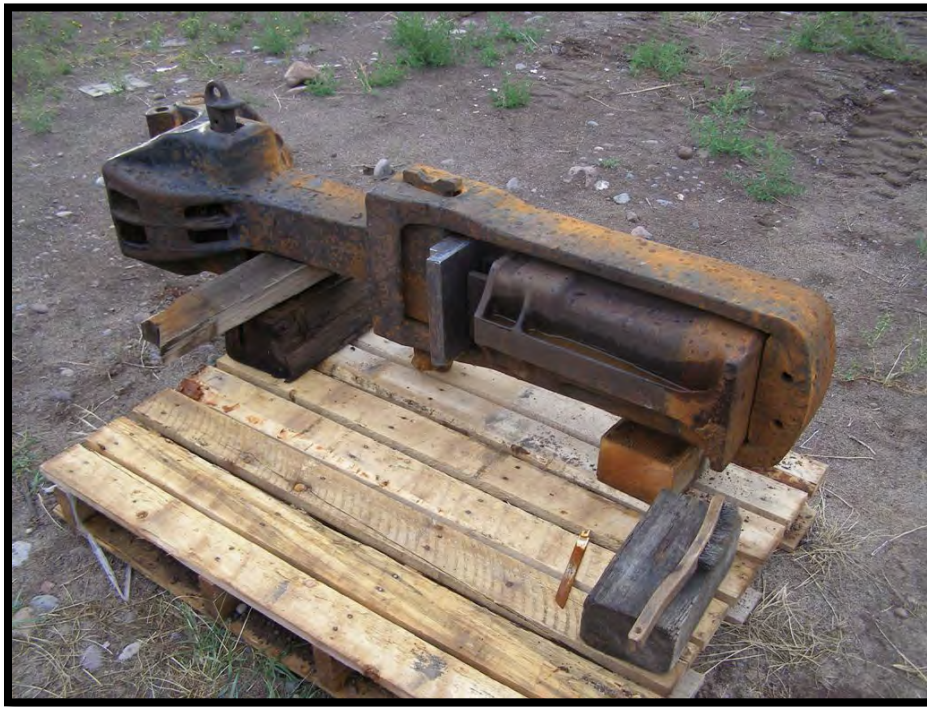
This view shows the coupler and draft gear fully assembled and ready for installation.

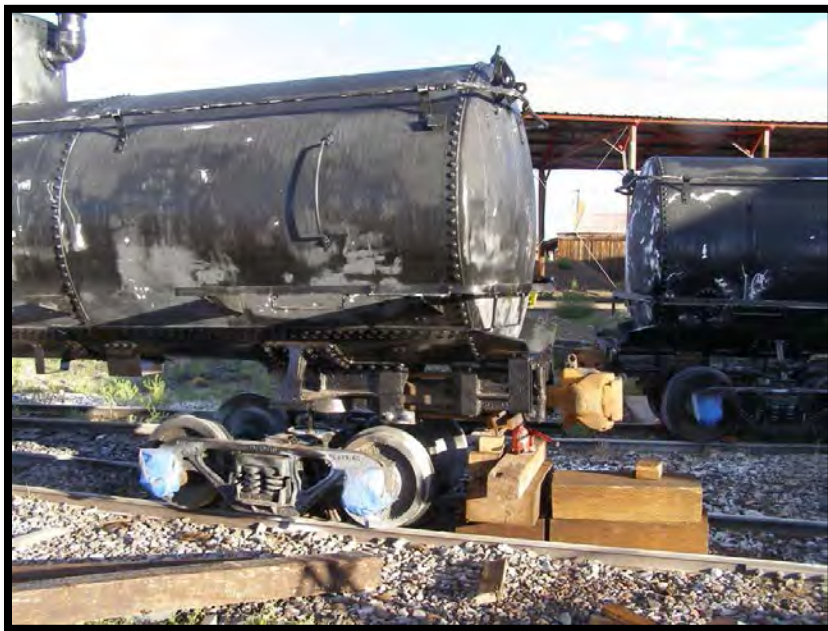
In this view the draft gear and coupler are fitted-up and the car is being readied to be lowered back onto the truck.

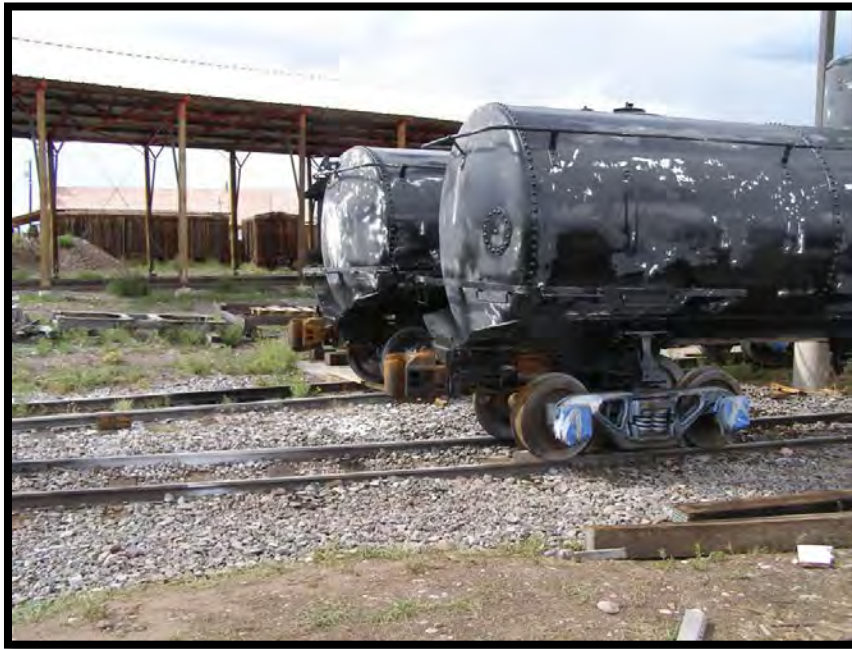
View of both tank cars at the end of session F with couplers and draft gear installed.

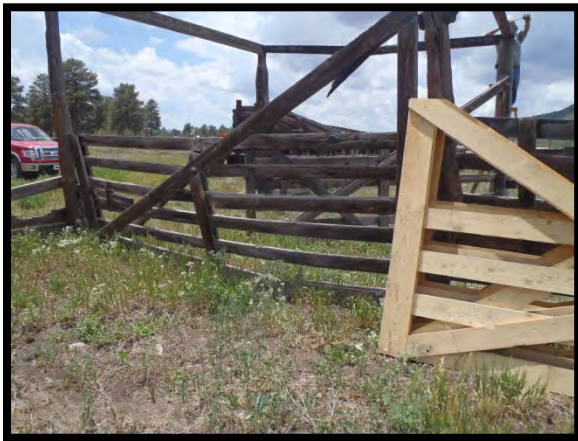
Gate in the process of falling down – old gate will be removed and new gate installed in either Session E or F.

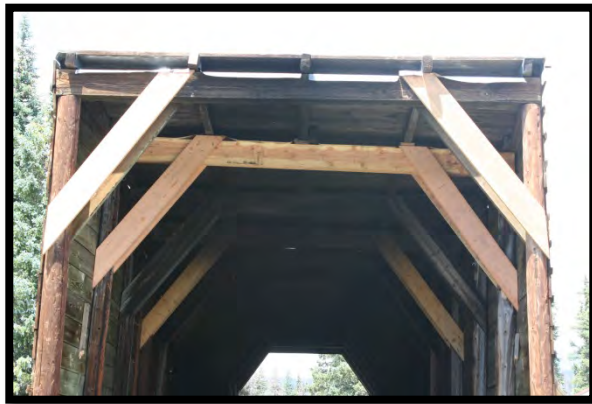
New angle supports installed.

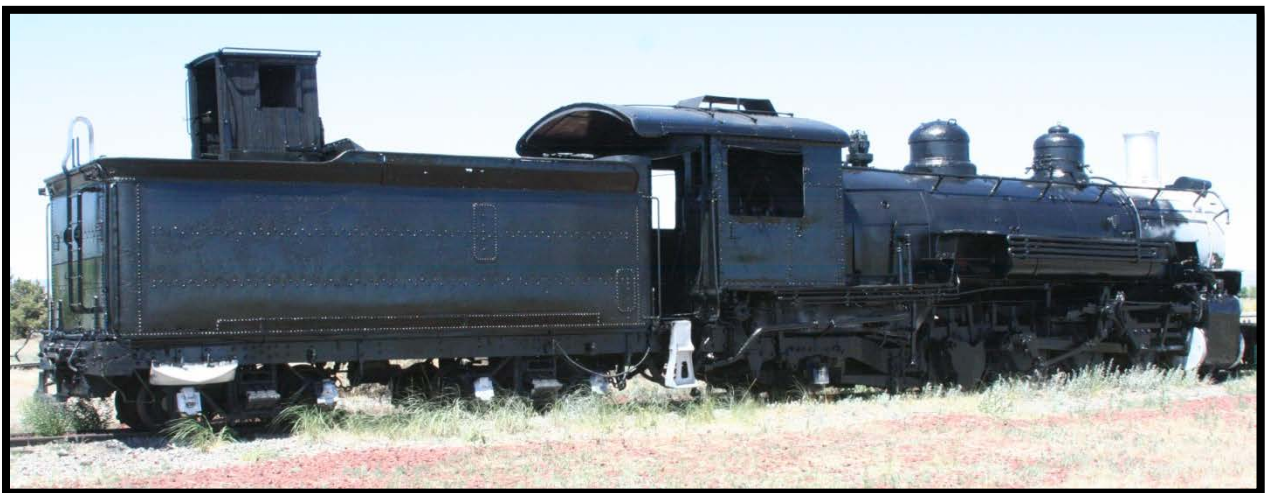
Display locomotive 494 has been painted black. The silver trim will be painted in August.

The engine was then primed with a Railroad furnished oil based primer on Tuesday. Five gallons of the primer was used to cover the boiler, frame, cab, and tender. After drying overnight the primer was covered with a coat of the Railroad furnished gloss black oil paint. The stored 5 gallon can of silver paint could not be located, but two used cans of silver paint were found. They were not useable (resin separated from pigment). The silver trim will be painted in Session F in August.

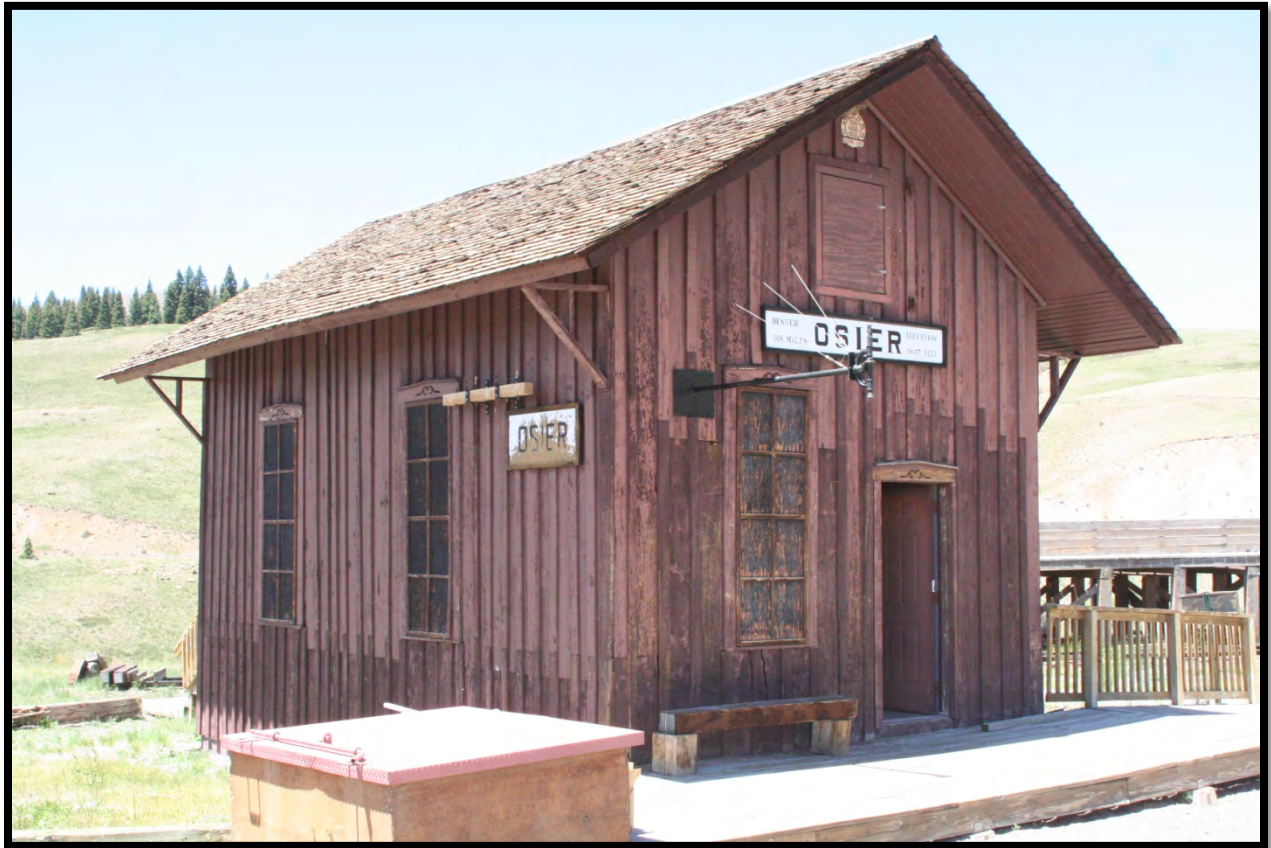
Osier Station was scraped and wire brushed to remove some old paint on Tuesday. Old swallow nests were knocked down as well. The sign on the south side needs repair. It appears to be Vinyl lettering on a painted pressboard backing. The sign on the rear of the station also needs repair. The North side and front are OK.

The station was masked off (doorknobs, decks and railings) then primed with oil based primer on Thursday morning. Five gallons of primer were used for this. The station's final coat of oil based dark brown paint was added on Friday morning. The black window panes will be touched up in Session F.

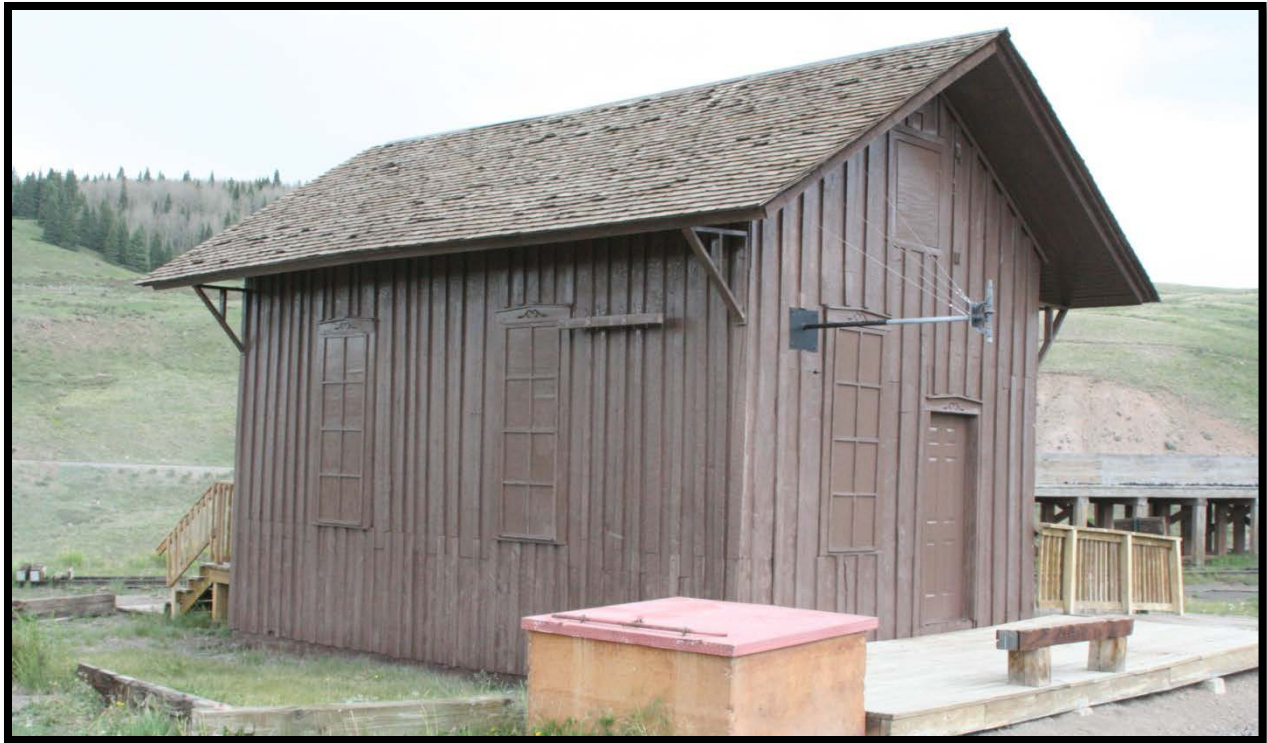
Note that the oil based finish coat did not adhere well in the cracks to the primer. See the photo below. This is the second coat of paint. I suggest another coat of Latex paint to fill the cracks in the paint. This can be done in the F Work Session.

The station as finished at the end of Work Session D.

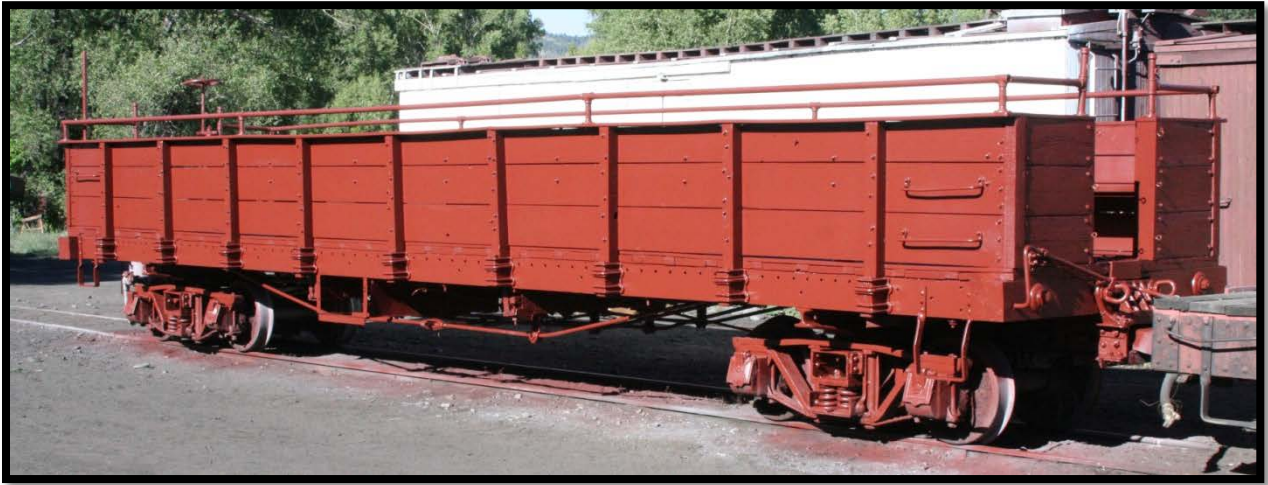
Rider Gondola 6205 has been completed and is ready for lettering and the Cinder Bear Train.

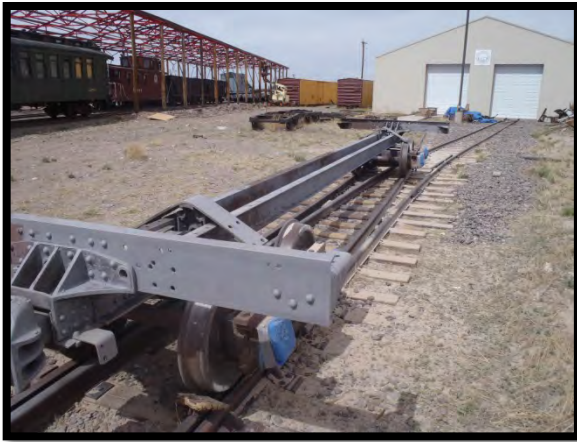
Frame was sand blasted in Session B by the outside contractor that sand blasted the two frameless tank cars.

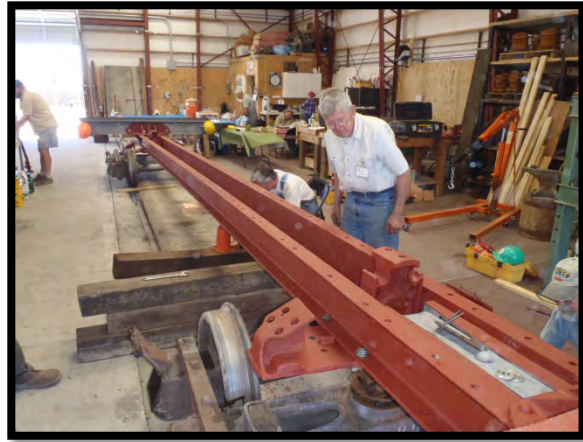
Frame coated with red oxide primer.

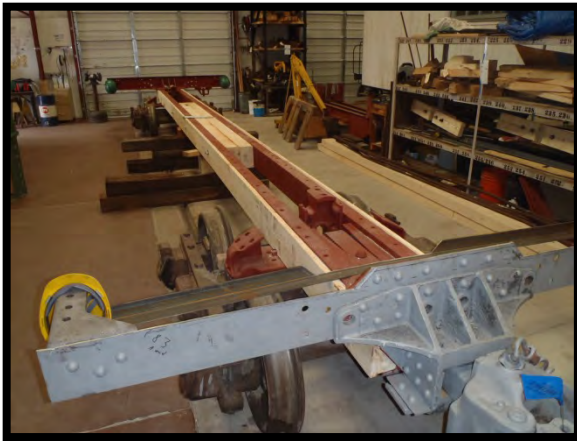
Angle iron has been cut and grinded to fit and will be welded in a later work session.

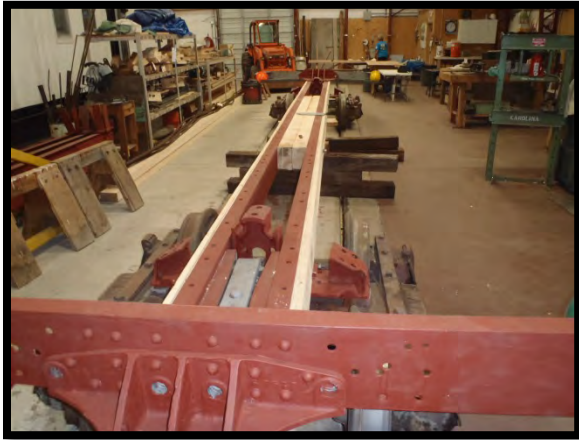
Center wood stiffing beams and two wood frame channel beams have been installed.

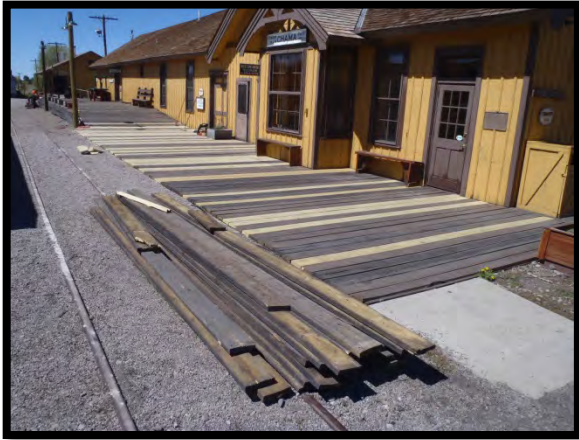
A pile of old 2 X 6's that have been removed and part of the new ones installed.

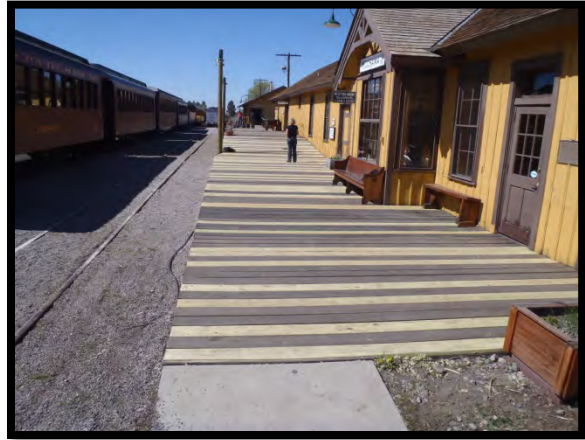
All 71 2 X 6's are in place.

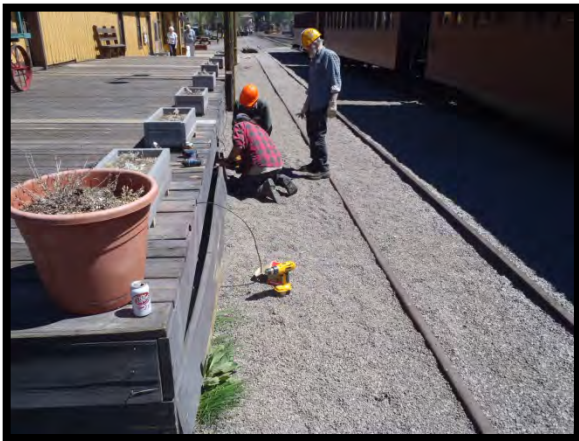
TL Ron Lira, Alan Robson & Herbert Druby removing a 2 X 12 that was nailed on and replaced the nails with screws.

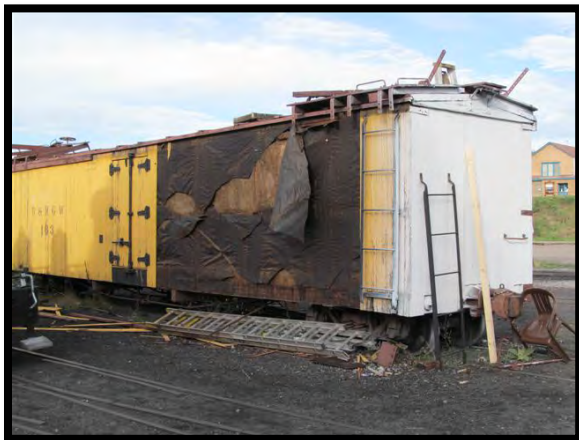
Old paneling being removed.

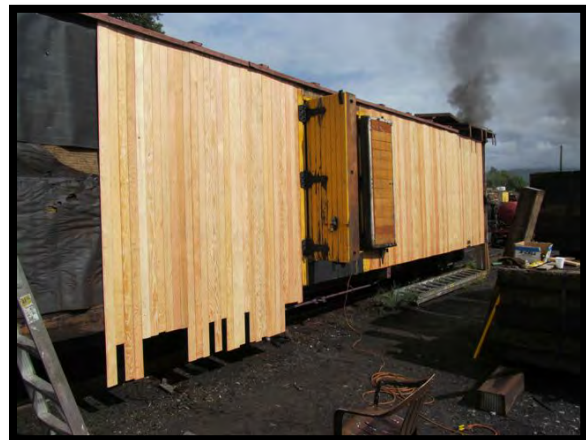
New paneling being installed.

New paneling was then installed after new tar paper was placed on the upper half of the car to repel moisture. One team member successfully rethreaded several bolts that had been cut or

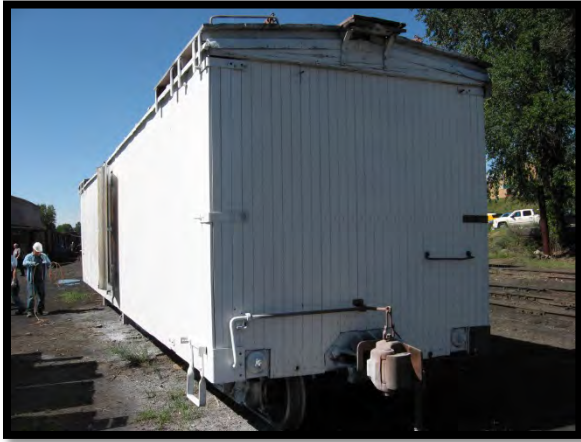
All of the new siding was primed on the last day of Session F.

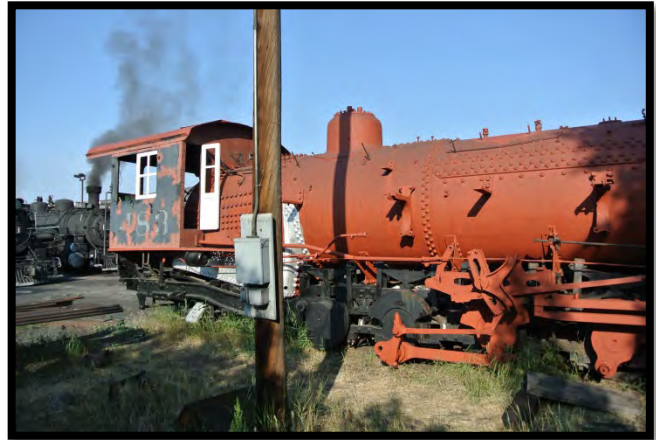
Engine 483 at the end of Session D shows a cab door and window installed.

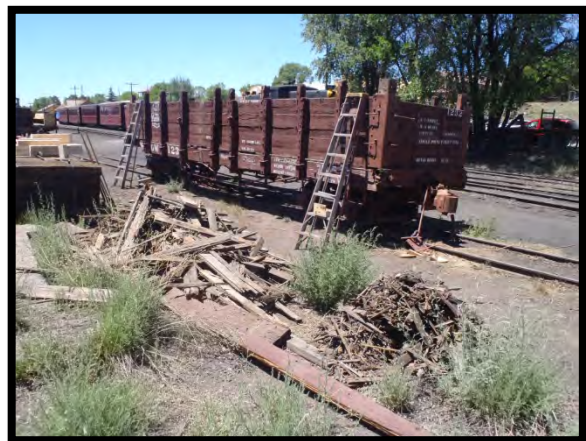
Two different piles of rotten wood out of 1232.

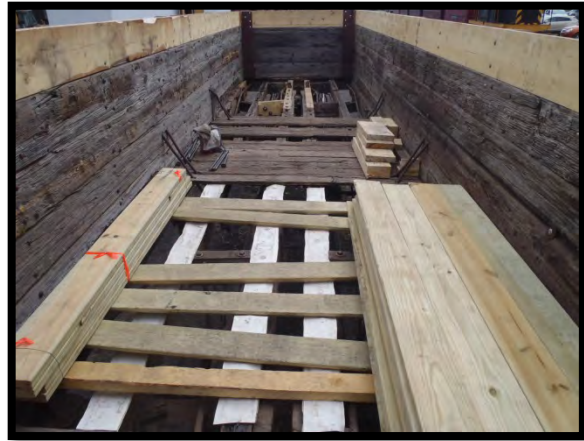
Protective rubberized strips (in white) has been placed over the sills to protect them as much as possible against the elements.

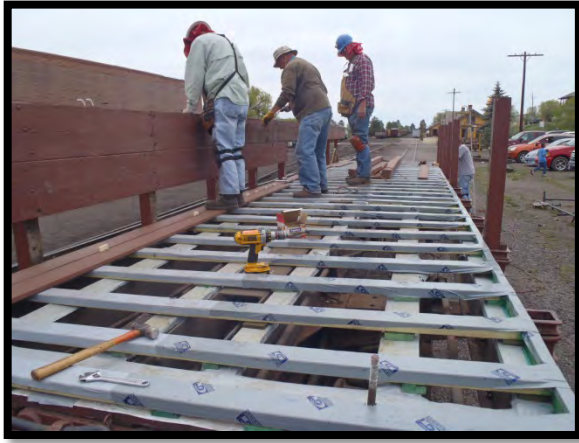
George Trever, George Davies & Dan Sandt Work on one side. All of the 2 X 4's have been covered with a rubberized membrane to protect them as much as possible from the various Chama elements.

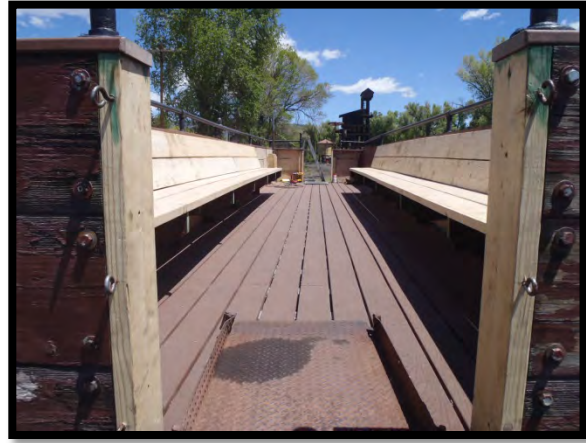
New benches, new TREX flooring, some new wood on the side-walls and ready for paint.

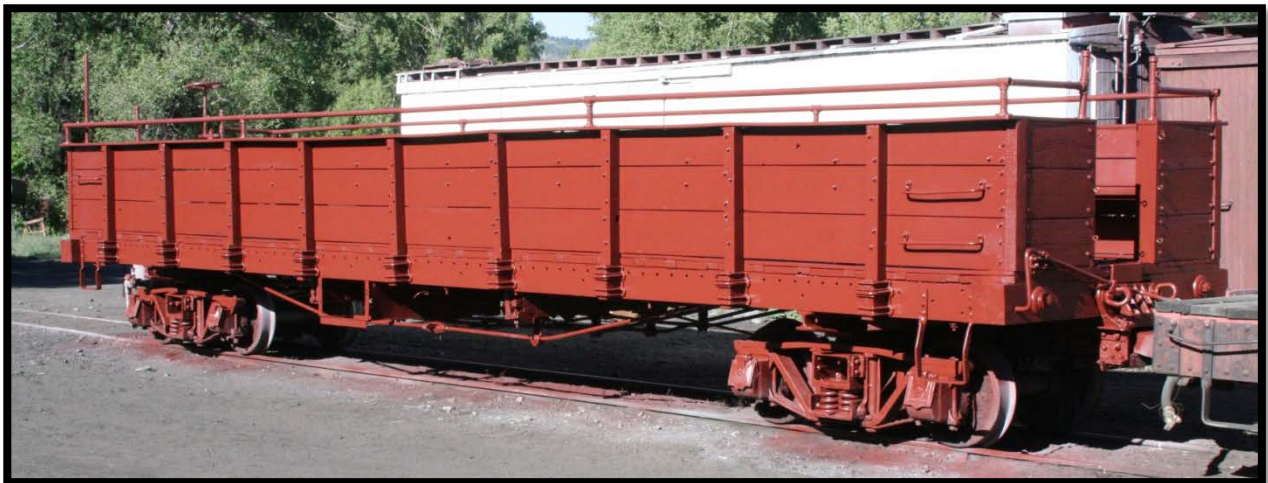
Rider Gondola 6205 has been completed and is ready for lettering and the Cinder Bear Train.
