Job 1017 Coal Tipple Restoration - 343.994

Objective: Restore the Chama Coal Tipple using the winter, 2002, Structure Report/Maintenance Plan by Kells/Kreis.

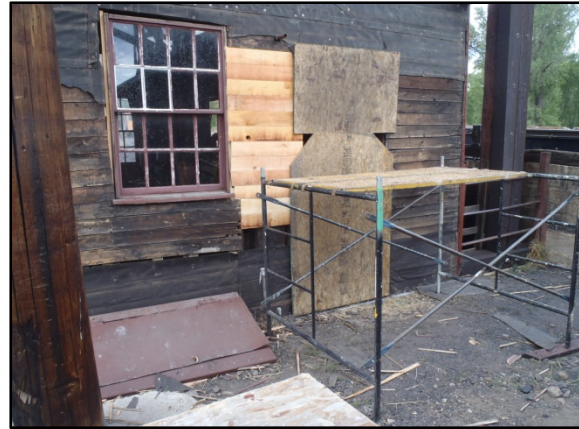
South side door boarded up overnight.

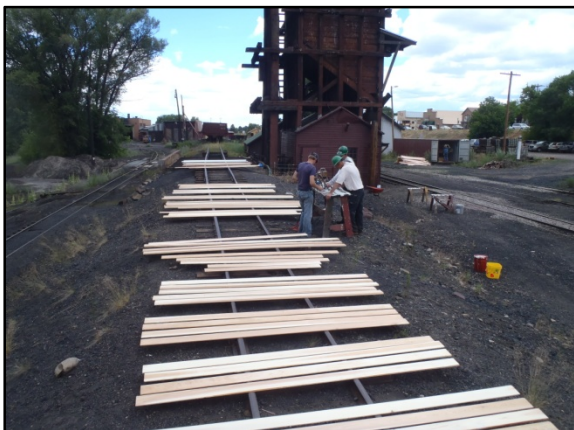
New siding spread out for priming.

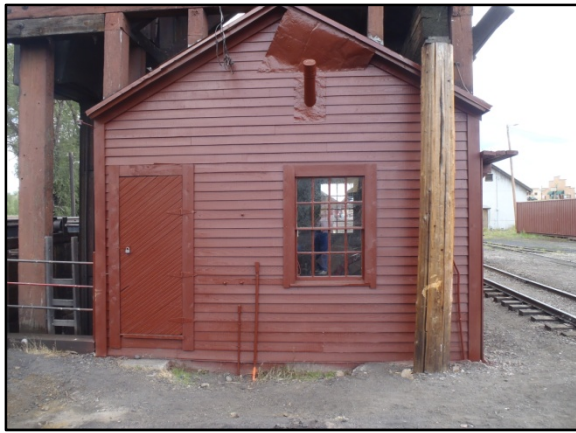
Newly painted north side of the hoist house.

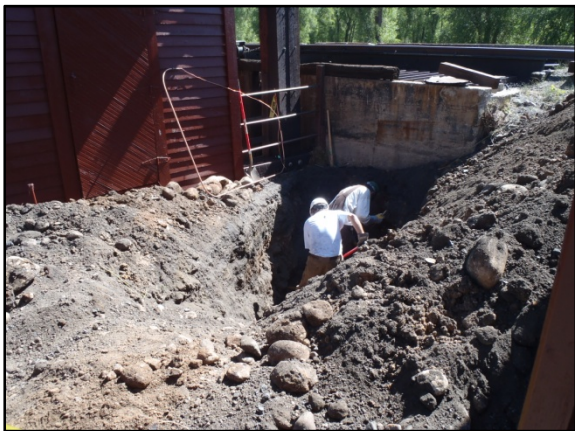
Against the hoist house is the lightning protection ground loop.

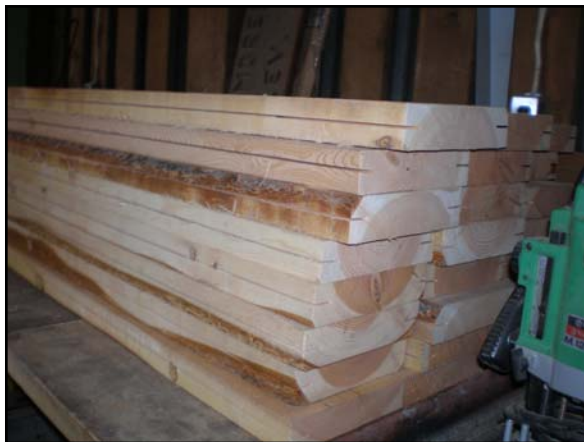
First cuts to make the ship lap pattern have been made.

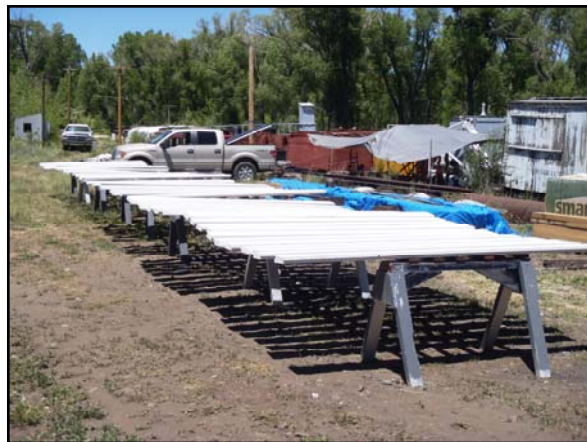
Painted 2 x 8 ship lap decking drying.

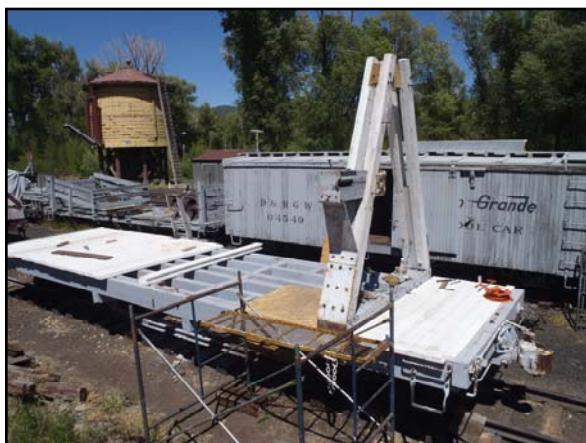
Decking has been notched underneath where necessary in order for it to lay flat when nailed in place.

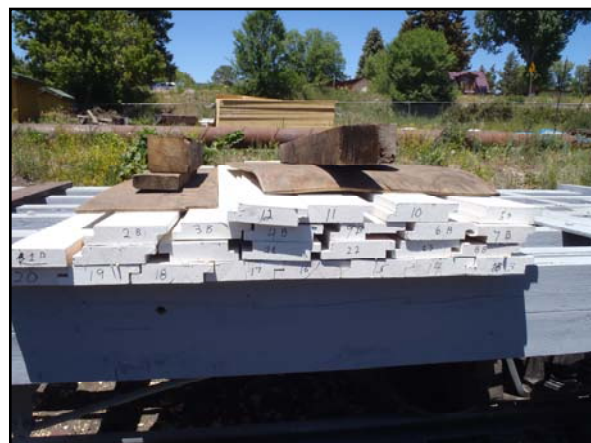
Decking was numbered in order and then stacked until Sessions E & F.

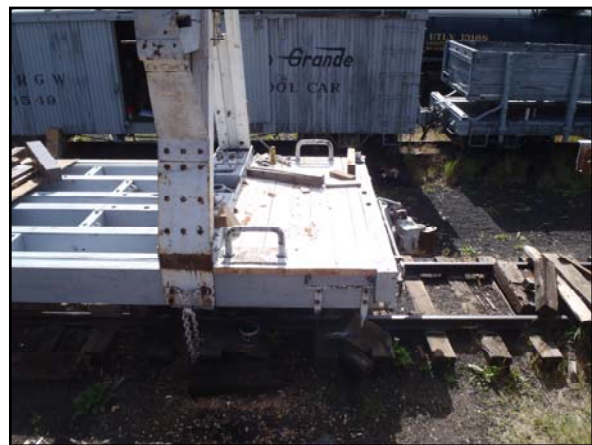
Outer supports/hold-downs have been reinstalled and secured – one on each side.

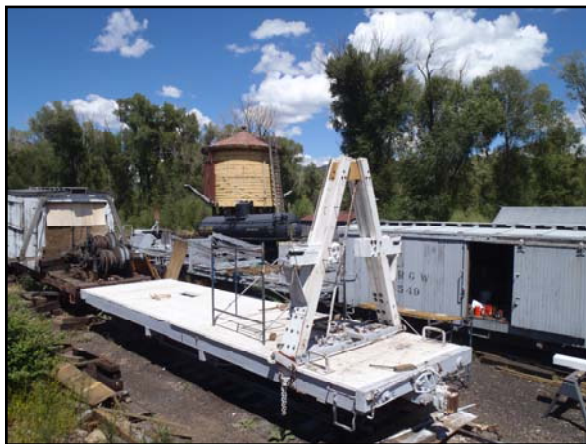
Car with the deck nailed down at the end of Session E.

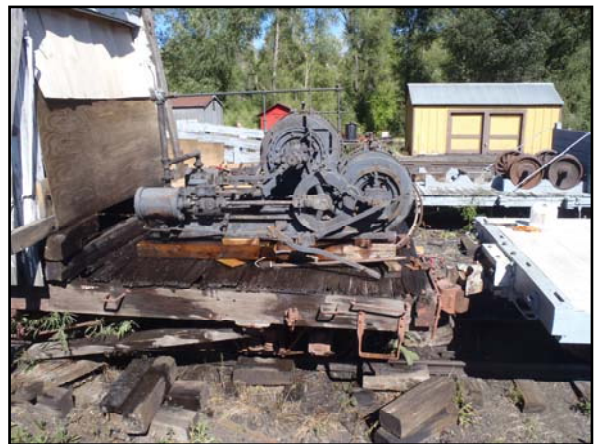
The double drum winch after being power washed by Don Duell for most of one day. It actually cleaned up very well.

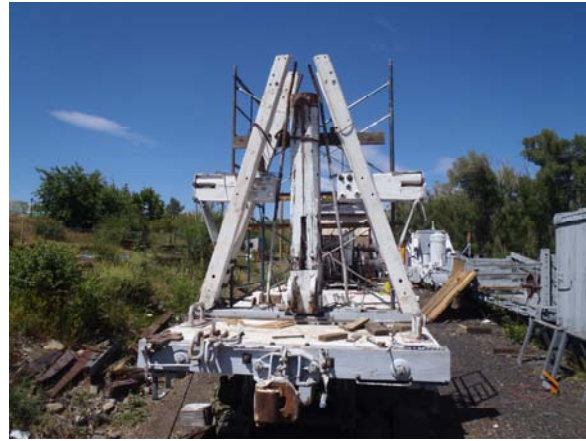
The pivot post has been set in place.

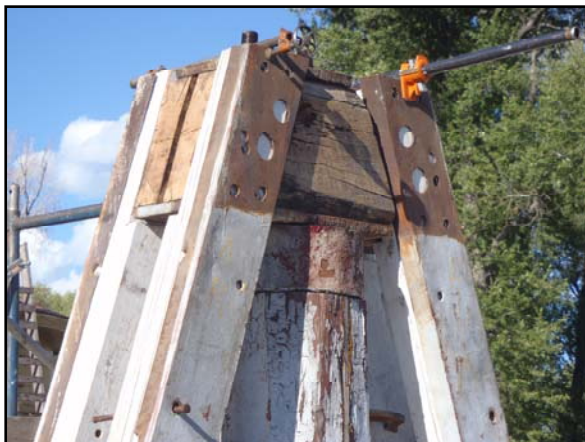
Crown assembly in place ready for holes to be drilled and bolts installed.

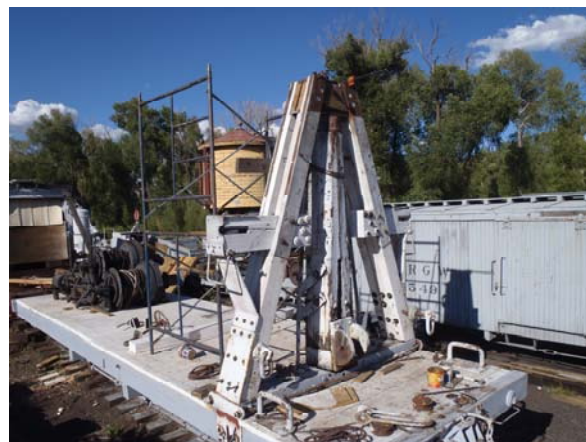
The double drum winch assembly has been moved back onto the car and the pivot post has been secured.

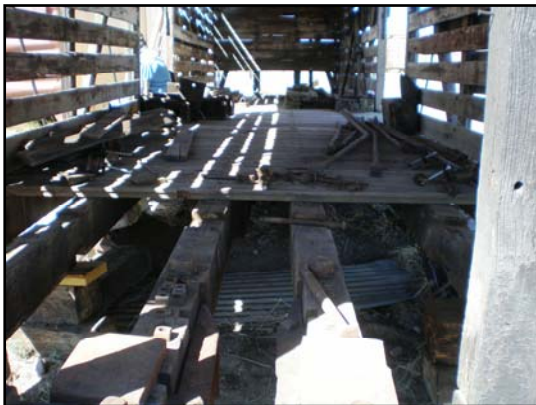
Part of the flooring has been removed.

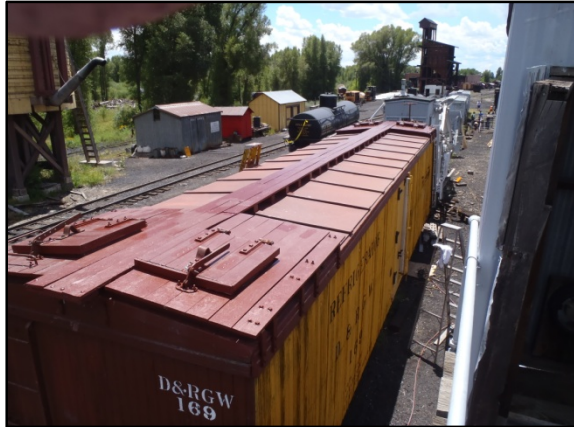
Hatches and catwalks newly hand painted.

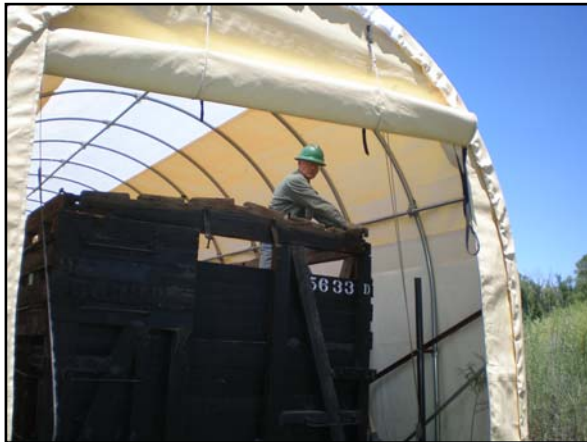
Team Leader Scott Hardy removing old roof roofing material.

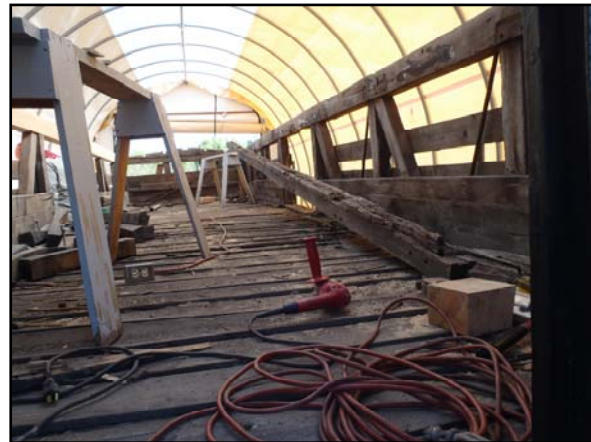
Most of the old roofing material has been removed.

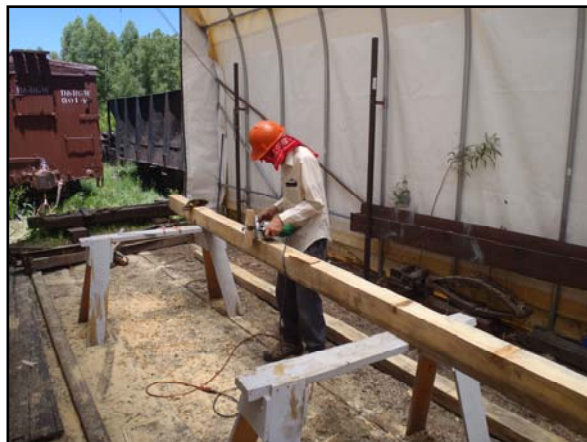
George Detwiler working on an upper side sill.

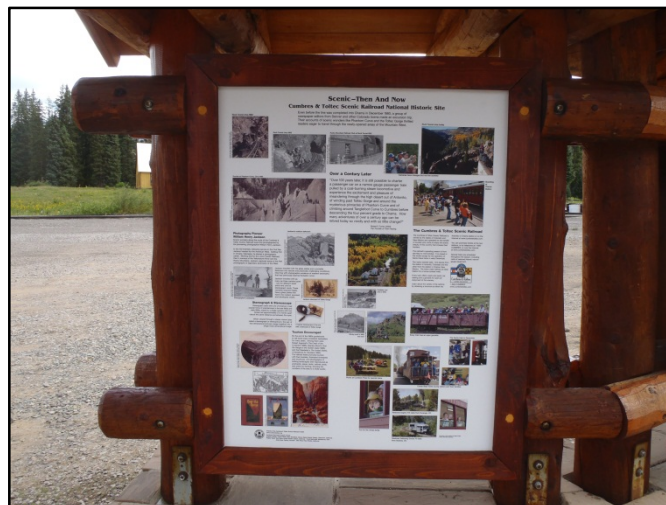
Replacement panel has been installed and some staining has been done.

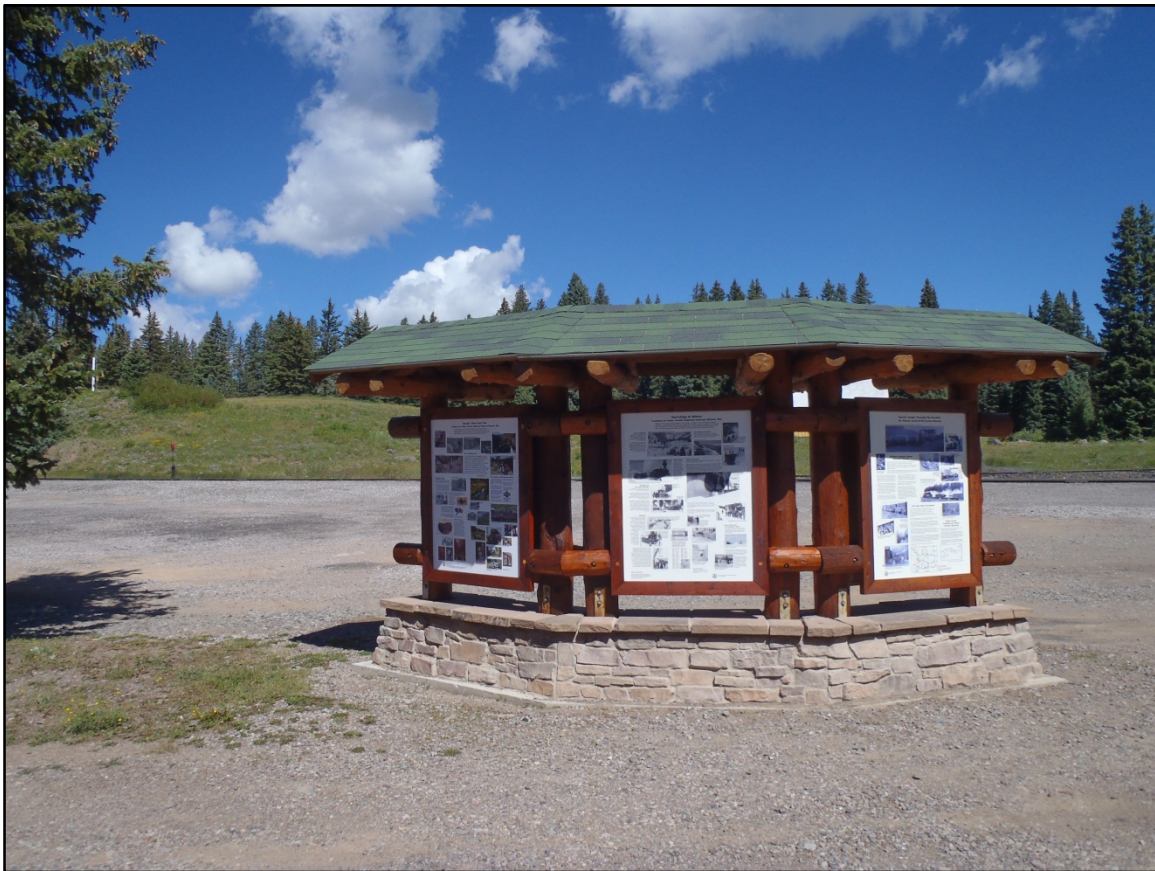
Kiosk replacement panel installed and Kiosk with new stain making it look brand new again!

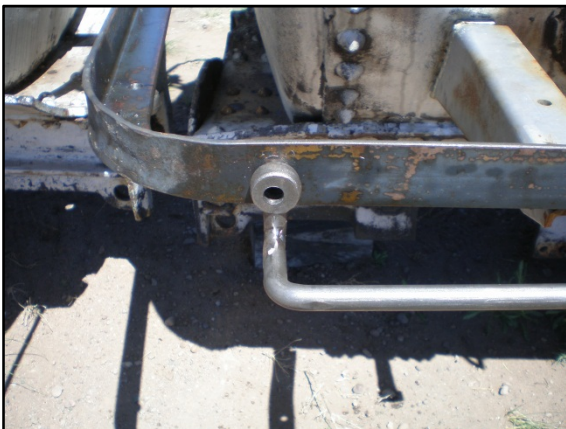
New grab iron in place – ready for a rivet.

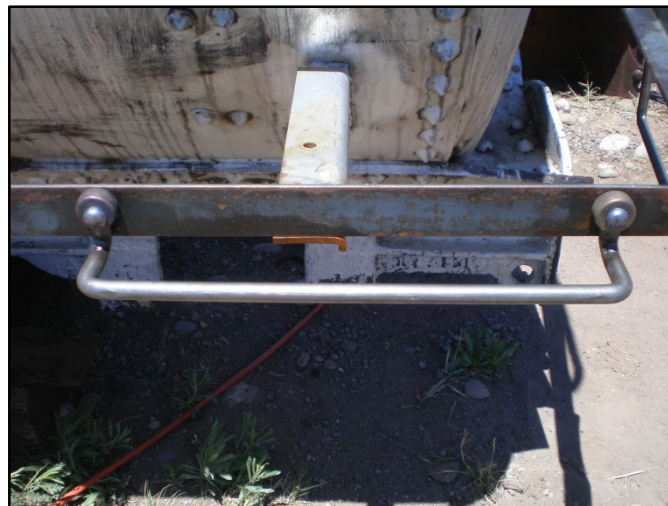
New grab iron riveted in place – just like the old days!

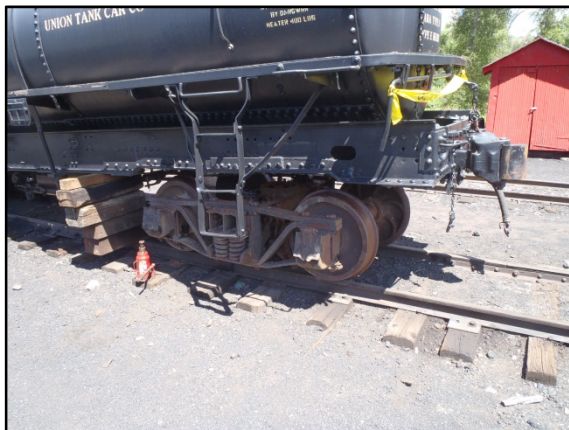
Arch-bar trucks have been moved under the tank car.

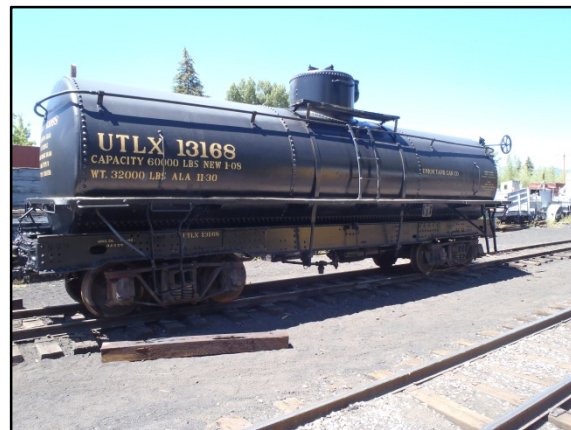
UTLX 13168 with newly installed arch-bar trucks under both ends of the car.
